Technical Report No. 32-548

# Metallurgical Examination of Development-Type Thermionic Power Converters

E. C. Bernett

JET PROPULSION LABORATORY
CALIFORNIA INSTITUTE OF TECHNOLOGY
PASADENA, CALIFORNIA

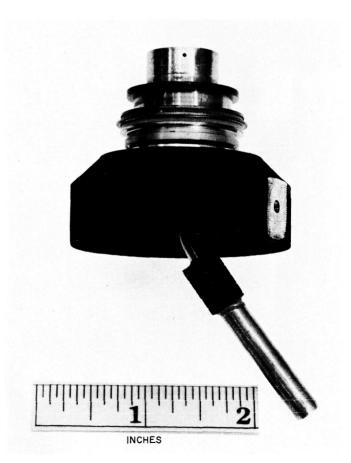
Fig. 1. External view of thermionic diode, Serial No. Vb

The outstanding external feature of diode Vb at first glance was the apparent coating of copper on the alumina insulator (see Fig. 1). It seemed that this would produce an electrical short; however, a continuity check was negative. The other notable features were (a) the large grain size and prominent thermal etching on the emitter (Fig. 3) and (b) the circumferential band of dark spots on the sleeve (Fig. 4). The spots were later found to be points of cesium leakage. The grain coarsening in the emitter is more apparent in the sectional view in Fig. 5.

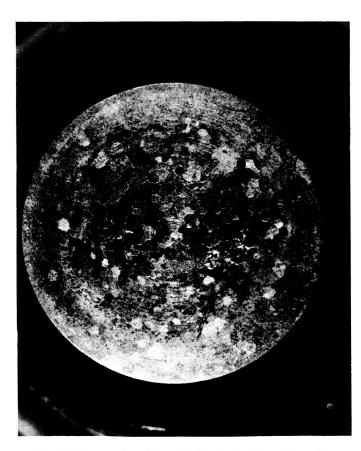
Fig. 3. Thermal etching of the diode Vb emitter face (heated surface). Mag, 5X

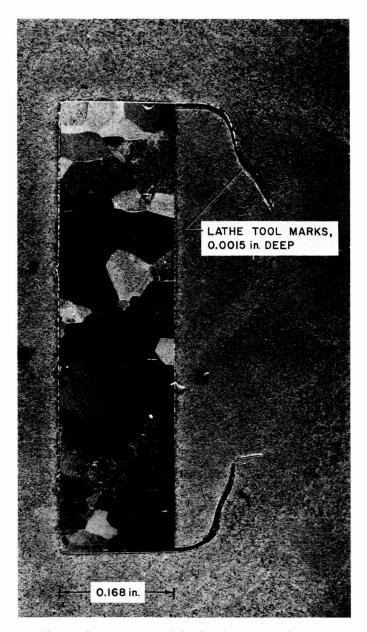
The last feature of note in the visual examination of this diode was the poor machining finish in various places and especially on the inside surface of the sleeve. The tool marks here were as much as 0.0015 in. deep, and since the unreinforced portion of the sleeve is only 0.0035 in. thick, the actual metal thickness at the bottom of the tool marks was only 0.002 in.

Fig. 5. Cross-section of diode Vb emitter, showing coarse grain size and deep tool marks

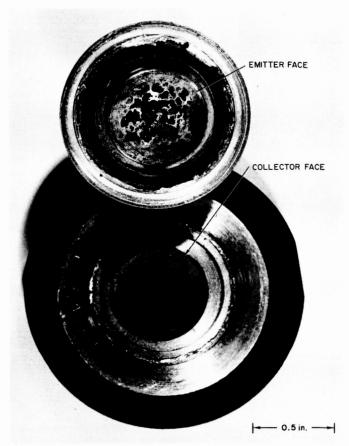
The diode was cut open (at point Z in Fig. 2) to permit examination of the inside. A peculiar greyish "etch" pattern was noted on the working faces of the emitter and the collector (Fig. 6). There was insufficient buildup of foreign matter to permit any spectrochemical analysis.

Fig. 6. "Etch" pattern on working faces of emitter and collector, diode Vb

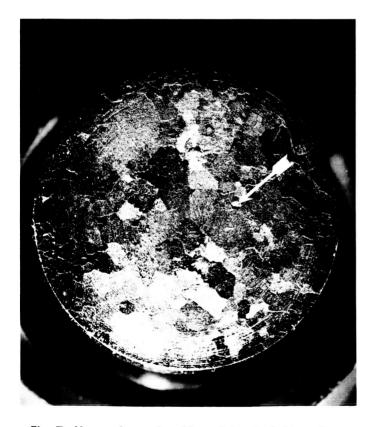
of the heated surface of the emitter (Fig. 7). The grain size was larger, and some grains were later found to extend through the full 0.167-in. thickness of the emitter (Fig. 8). The grain boundaries, which were very prominent, were opening, and one grain had become separated and had fallen out. Also, there were a number of small rounded protrusions on the heated surface of the emitter; these looked like beads of previously molten metal.

Fig. 7. Heavy thermal etching of the diode Vc emitter face (heated surface). Note that one grain has fallen out. Mag, 5X

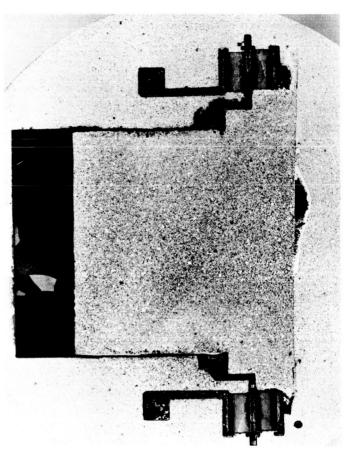
Fig. 8. Section through emitter—seal portion of diode Vc. Mag, 4X

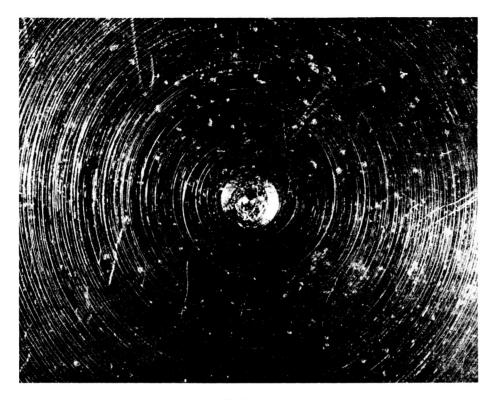
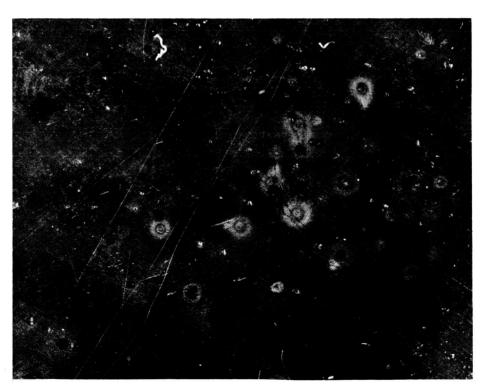
The diode was then cut open and the internal surfaces were examined. The emitter face was clean all over. The tool marks were prominent across the full face and the grain structure was just distinguishable. The grains were equiaxed and the average size was about 0.040 in. Closer observation of the emitter face showed numerous clean pits just visible to the naked eye. The condition of the collector face was markedly different from that on diodes Vb and Vc, described previously. The collector face on diode VI was clean except for a number of small dark spots (the largest being about 0.02 in. across). Also present on this face were numerous very small bumps. These

looked like metal splatter one normally sees near arc welds. Views of the emitter and collector faces are shown in Fig. 9.

Fig. 9. Condition of working surfaces of emitter and collector on diode VI. Mag, 10X

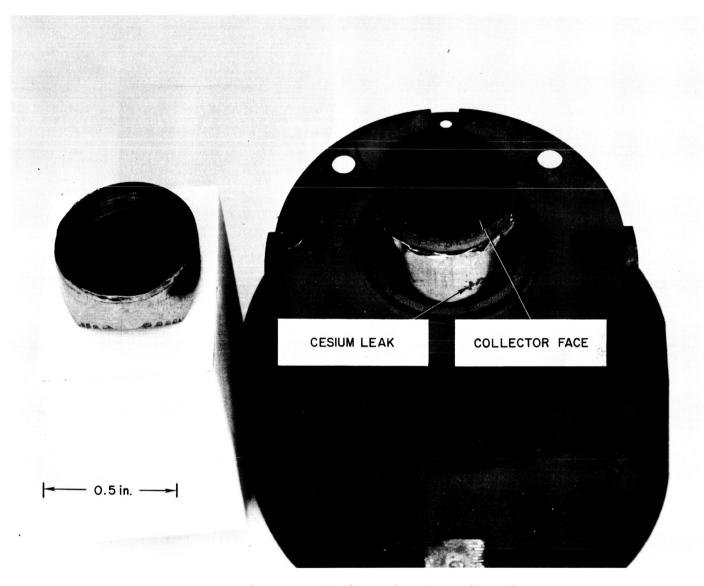
This unit developed a cesium leak in the tantalum sleeve after a relatively short total test time of about 50 hr. The diode had been cut open by the supplier (see Fig. 10). The heavy dark deposit on the collector face is plainly evident, as is the point at which the cesium leak occurred. A closeup of this point is shown in Fig. 11 (external view) and an internal view is shown in Fig. 12. This grain boundary attack (Fig. 12) was confined to a belt approximately 0.1 in. wide and extended the full circumference of the sleeve. The sleeve was brittle in this zone.

The working surface of the emitter was clean except for a smudge of deposit (Fig. 10) which had rubbed off the collector after the unit had been cut open. Of the

Fig. 10. Diode VII, as received. Note deposit on collector face

four units under examination here, the collector face on this diode was the dirtiest. A dark grey powdery deposit about 0.003 in. deep was present on the whole surface. The outer material could be readily scraped off; however, the last 0.001-in. layer (next to the metal) was highly adherent.

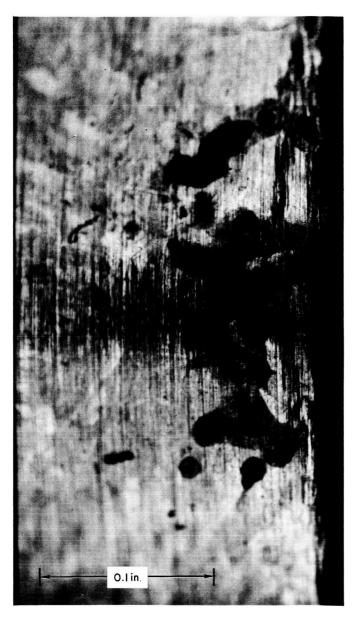
Fig. 11. Cesium leak area on sleeve of diode VII, outside view

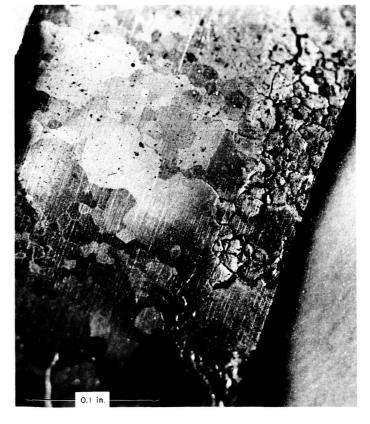
Fig. 12. Cesium leak area on sleeve of diode VII, inside view

Microprobe analysis was also done on the corrosion product that was extruded from the grain boundaries of the diode VII sleeve (Fig. 12), and a high percentage of cesium was found. Cesium could not be detected on the parent tantalum away from the boundary region.

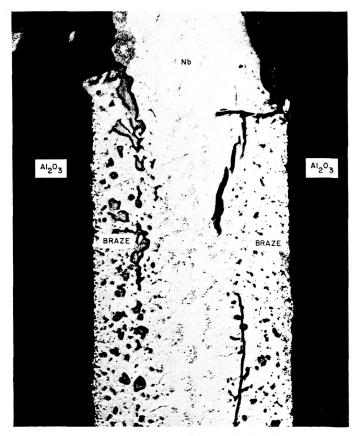
- 1. There was a particularly noticeable difference in the structure of the metal-to-ceramic braze in the Series V, VI, and VII diodes, as may be seen in Fig. 13, 14, and 15, respectively. In the case of diode Vb (Fig. 13), there was a very heavy intergranular diffusion of the brazing filler into the niobium. This had embrittled the niobium, as evidenced by the cracks through the metal along the region where the alumina had broken away when the sample was cut. The diode VI braze (Fig. 14) showed no evidence of any gross diffusion of the filler metals into the niobium, as was observed in the previous unit. In diode VII, the braze filler had apparently segregated into nickel- and copper-rich zones (Fig. 15). Further information on the metal-ceramic seals is given later in the sections on microhardness and microprobe studies.

Fig. 13. Alumina-to-niobium braze, diode Vb. Note that braze joint on the right had separated during sectioning. Mag, 100X

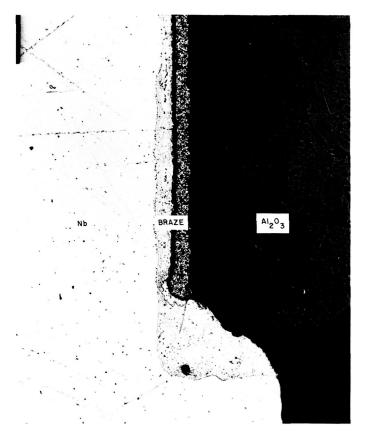
Fig. 14. Alumina-to-niobium braze, diode VI. Mag, 100X

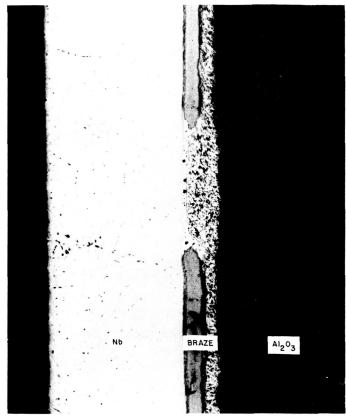
Fig. 15. Alumina-to-niobium braze, diode VII. Mag, 100X

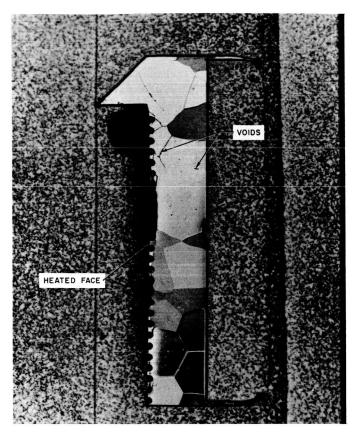
- 2. As was mentioned previously, one of the striking external features of these diodes was the coarse grain size of the emitter and the severe intergranular cracking of the heated surface. Cross-sectioned views of the diode VII emitter at low and high magnification are shown in Fig. 16 and 17. The intergranular voids are concentrated near the heated surface; however, one void may be observed more than three-quarters of the way through the emitter. In units that are expected to operate for very long times, this might be a major problem.

Fig. 16. Section through diode VII emitter. Note coarse grain size and intergranular voids. Mag, 10X

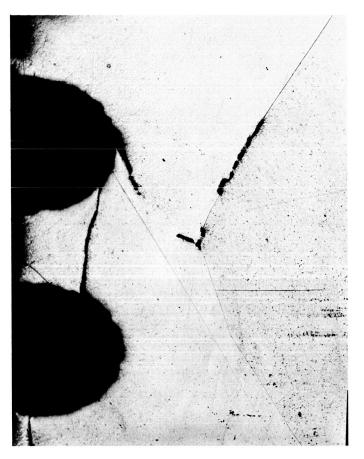
Fig. 17. Intergranular voids in the emitter from diode VII. Mag, 100X

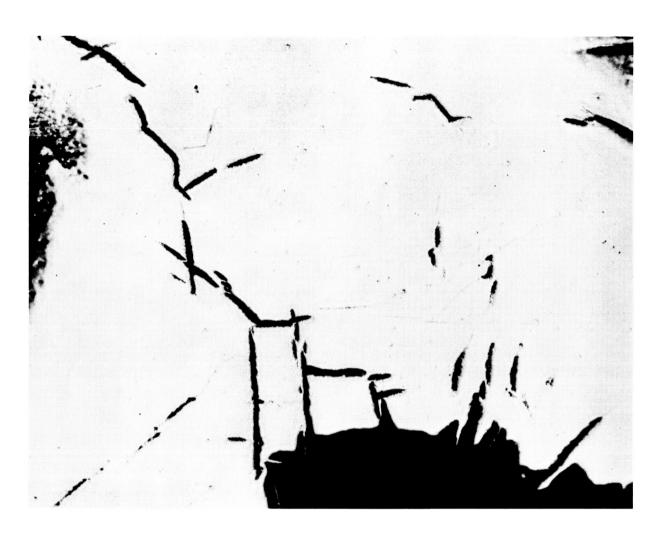
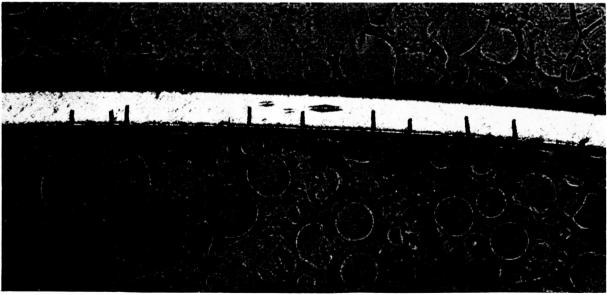
all the diodes in an attempt to determine why some developed leaks. Two views through the defective areas are shown in Fig. 18. The cracks, which originate from the inside surface of the sleeve, are intergranular and do not spread away from the boundary. This is more evident in the high-magnification view of one attacked boundary in Fig. 19. The reason for this attack could not be positively established.

Fig. 18. Grain boundary attack of tantalum sleeves. The top photograph shows a side view of the sleeve from diode VB and the bottom photograph shows a cross-section of the sleeve from diode VII. Mag, 150X

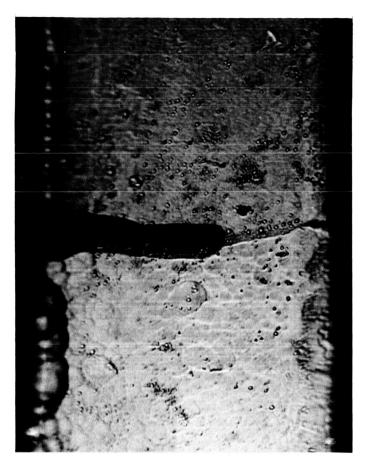
Fig. 19. Grain boundary attack on sleeve from diode VII. Mag, 1,000X

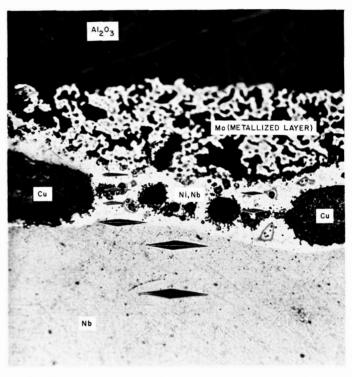
The previously described examinations had revealed a number of instances where gross diffusion or segregation of certain elements had occurred. This was particularly noticeable in the metal-ceramic braze joints. In the case of the Series V diodes there was a heavy diffusion of braze filler into the niobium support ring (Fig. 13). X-ray microprobe checks showed that both copper and nickel had diffused intergranularly into the niobium support ring, causing the hardening and embrittlement of this component. In the Series VII diode there was pronounced segregation along the metal-ceramic braze joint (Fig. 15). A high-magnification view of one area of this joint is shown in Fig. 20. The microprobe checks of this area showed that the light-colored phase (previously found to be very hard, i.e., 1,600 Knoop) was niobium base with 35% nickel, 6% copper, and 4% molybdenum. The darkcolored phase was principally copper, and the mottled material was the molybdenum metallizing. The metallized zone also contained amounts of titanium ranging from 1 to 14%.

Fig. 20. X-ray microprobe and Knoop microhardness survey through the metal—ceramic braze on diode VII. Mag, 500X
